# Health Monitoring Systems

**51<sup>st</sup> GARTEUR GoR Meeting  
Stockholm October 22, 2004**

**Appendix H**

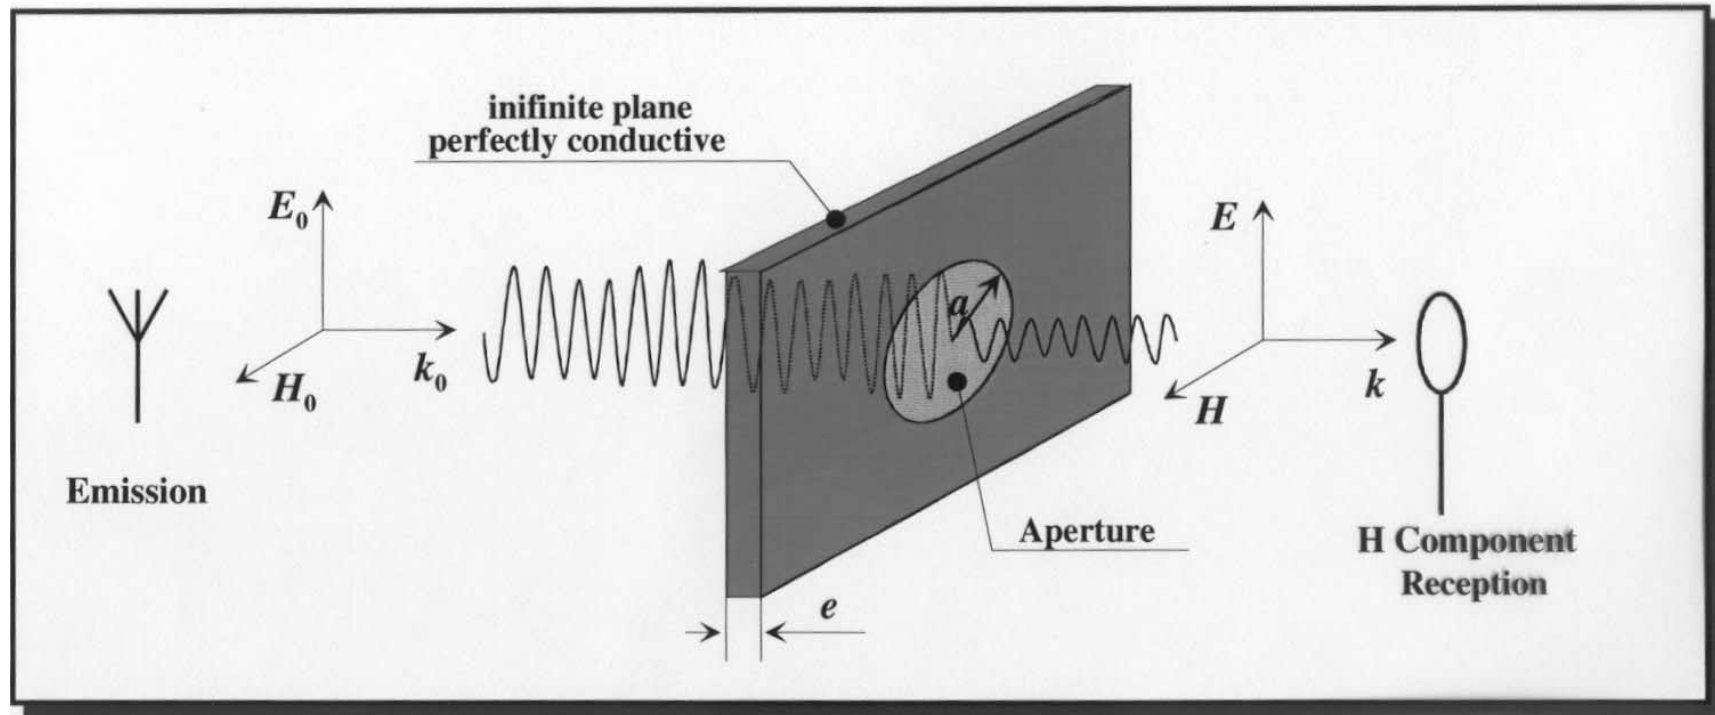
## ELECTROMAGNETIC BEHAVIOR OF COMPOSITE MATERIALS (i)

Model from K. F. Casey 1981)

- Skin effect negligible
- Small aperture compared to wavelength

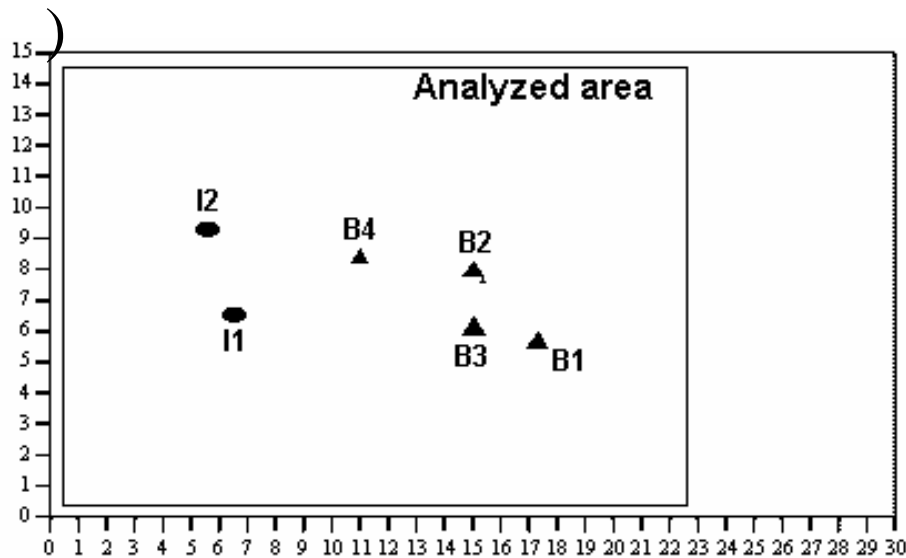
Integrated network system (Patent N° 040 003310 - 31/03/04)

**B1, B2, B3, B4, I2: Detected and localized**

**I1: No detected**

**Bn : burns, In : impacts**

**I1 : light impact (2 J) without fiber break**

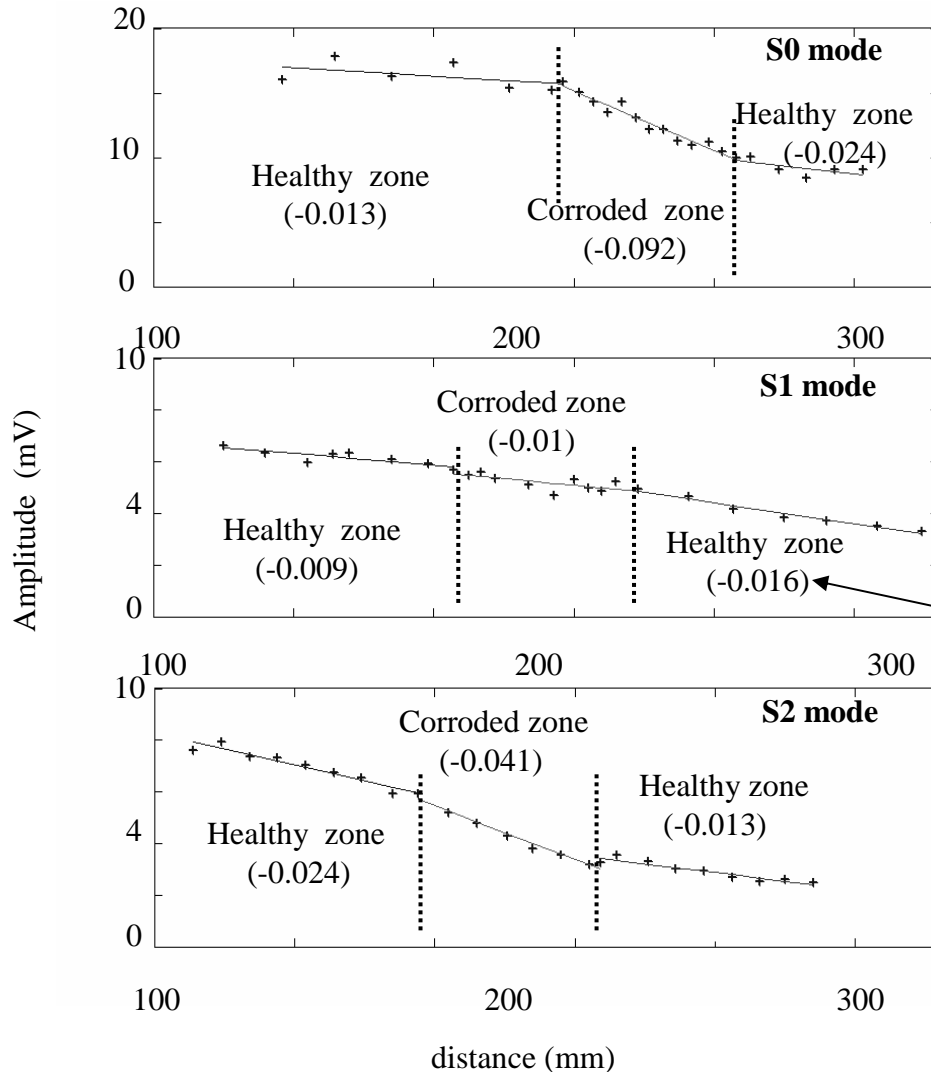
## Use of Lamb Waves (PhD Thesis N. Terrien)

Lamb mode	$\frac{\text{slope in a corroded zone}}{\text{slope in a healthy zone}}$
S0	4.97
S1	0.8
S2	2.22

Slope of the best-fitting line

**S<sub>0</sub> mode seems to be a good choice to detect corrosion**
